Railroad Investigation Report: RIR-24-01

Caltrain Passenger Train Collision with Hi-rail Construction Vehicles

San Bruno, California
March 10, 2022

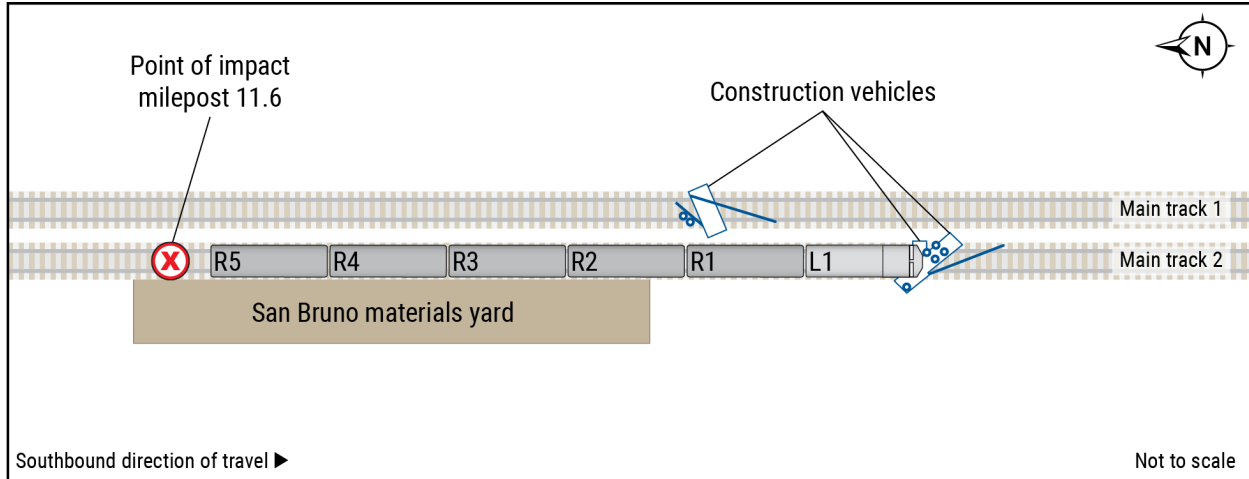
Figure 1. Illustration of the collision.

Train 506 was traveling from San Francisco, California, to San Jose Diridon Station and consisted of one locomotive and five passenger railcars. Event recorder data from the locomotive showed the speed of the train was 64 mph about 1/4 mile from the collision. The construction equipment was positioned on Main Track 2 at MP 11.6 with the pilot vehicle facing north, the crane was in the center position and also facing north, and the boom truck was behind the crane facing south.² As the train exited a left-hand curve, the engineer told the National Transportation Safety Board (NTSB) that he could identify construction equipment on a track, but he could not immediately identify which track the equipment was on. Event recorder data show the engineer applied the emergency train brake 13 seconds before colliding with the construction equipment. After applying the emergency brake, he sounded the train's horn to alert the construction work group of the impending danger and braced himself for impact. The train slowed to about 43 mph before it struck the first construction vehicle. The train then continued to strike the other two construction vehicles before stopping.

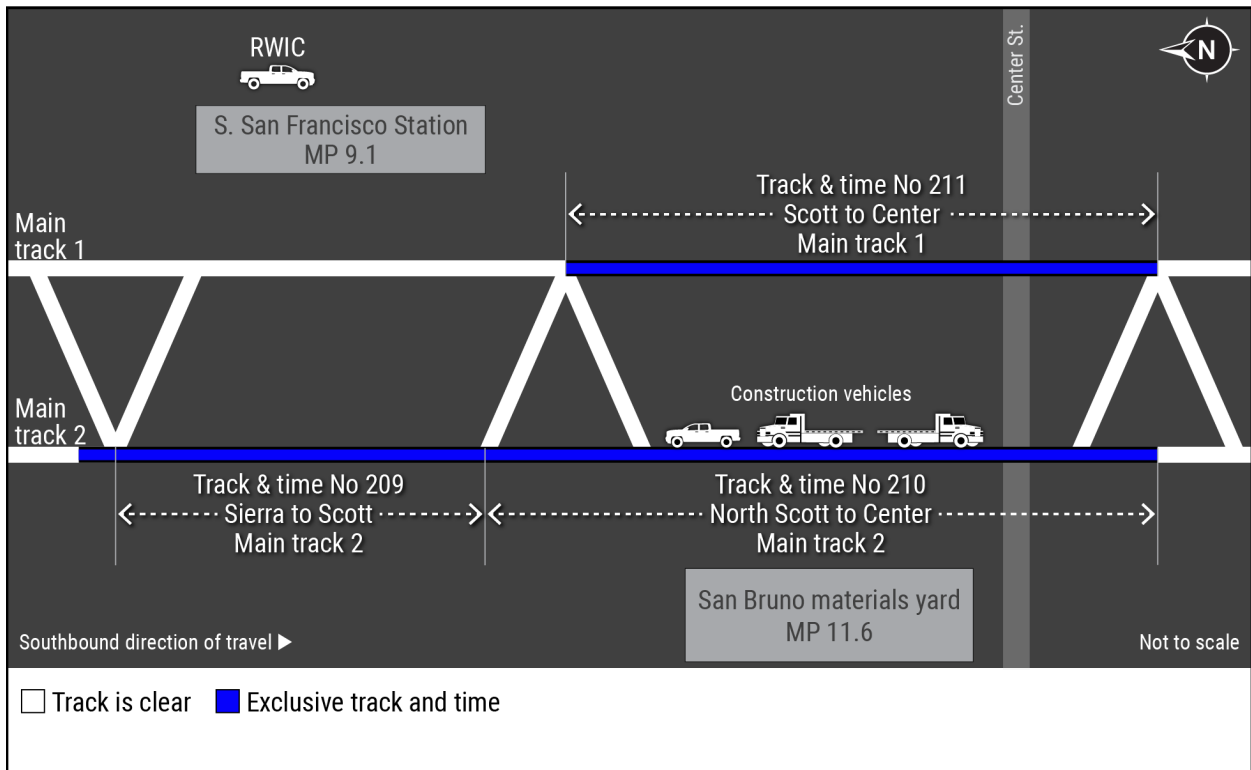
Phone records indicate that the RWIC placed a call to the subgroup coordinator (SC), who was managing the construction crew, at 9:33 a.m. After a conversation, the RWIC and SC determined that an additional track occupancy authority would be needed on the adjacent track, Main Track 1, to allow the construction vehicles to briefly foul both tracks while they maneuvered into position on Main Track 2. This resulted in a request for another form of on-track protection. At 9:43 a.m. the RWIC told the dispatcher that the work group needed Main Track 1 for 5-7 minutes, the dispatcher said that he would call the RWIC back. At 9:47 a.m., the dispatcher called the RWIC with Track and Time Authority 211, which was for Main Track 1 from CP Scott to CP Center Street until called. The dispatcher informed the RWIC they had about 7 minutes before a train would be ready to pass the area. Figure 2 illustrates the locations of the construction vehicles on the train dispatcher’s display.

Figure 2. Location of the construction vehicles on the train dispatcher’s display.
