Railroad Investigation Report: RIR-24-04

# 1 Port Authority Transit Corporation Train 2 Strikes Two Subcontractor Employees

Camden, New Jersey  
October 14, 2022

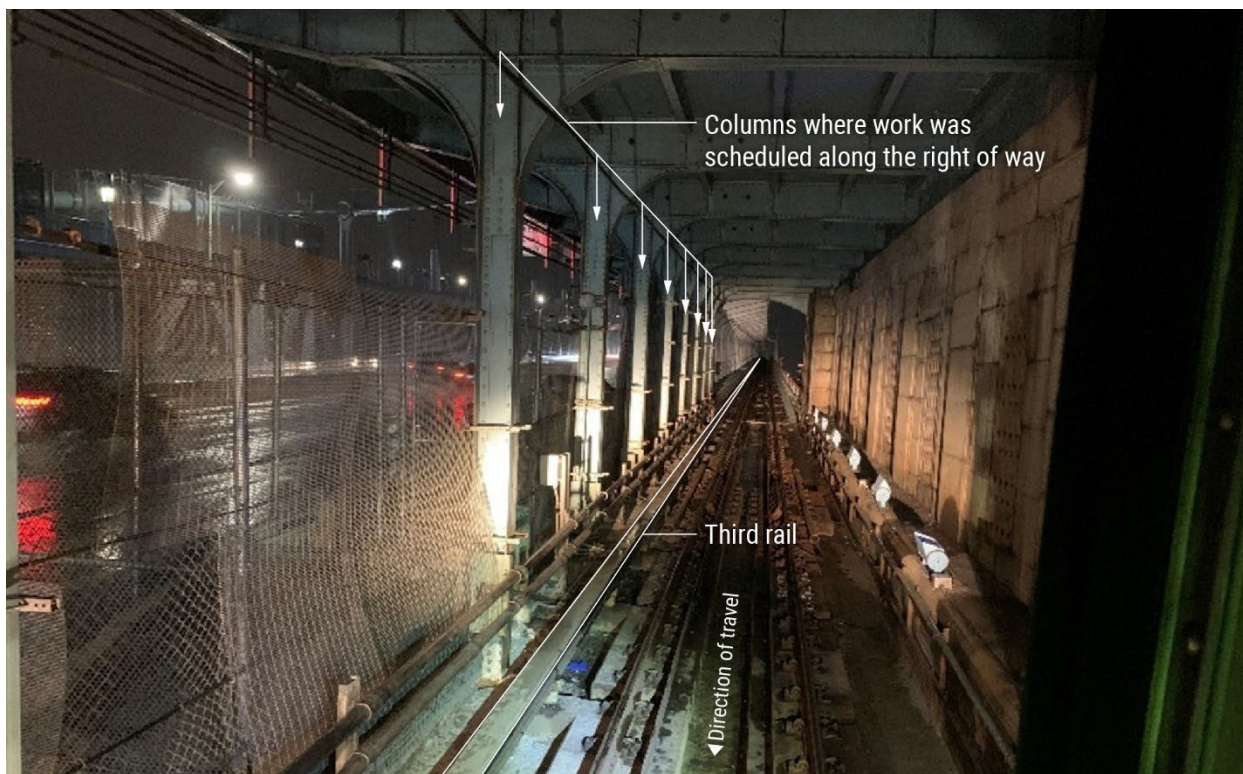
**Figure 2.** Photograph of Main Track 2, facing west, where the subcontractor employees were struck by PATCO train Westbound #1.

On the night of the accident, the subcontractor JPC Group employees met for a preshift meeting, including a job briefing, at 8:30 p.m. There were five employees in attendance, including the JPC Group supervisor. A Skanska Koch superintendent conducted a job hazard analysis with JPC Group employees. According to interviews the NTSB conducted with surviving attendees of the preshift meeting, the job briefing included work tasks and other safety points; however, it did not include ROW information, despite it being required as part of PATCO's ROW Safety Plan.<sup>8</sup> According to interviews, JPC Group subcontractor employees and a supervisor went to their work staging yard following the job briefing to get materials. The group departed in two vehicles to the bridge work areas. One vehicle had two JPC Group subcontractor employees that would be working in the ROW where the accident occurred, and the other vehicle had the JPC Group supervisor and the remaining employees that were working in a different work area—a pedestrian sidewalk not on the ROW. The two subcontractor employees that were assigned to work the site near the ROW were tasked with putting new caulking on 11 columns that were located next to the tracks. (See figure 2.) This was their third night working in this work area.
