# RAIL TRANSPORTATION SAFETY INVESTIGATION REPORT R25W0047

## MAIN-TRACK TRAIN DERAILMENT

Canadian National Railway Company  
Freight train G89641-28  
Mile 101.1 Fort Frances Subdivision  
Near Devlin, Ontario  
28 June 2025

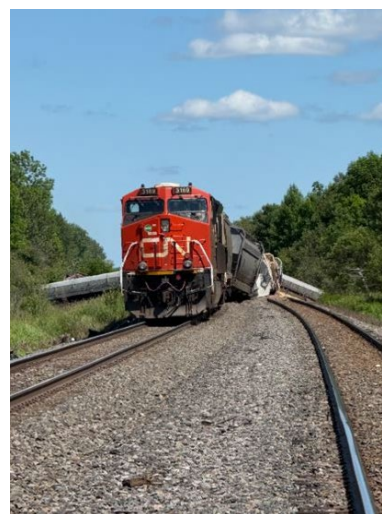
At about 1340 Central Daylight Time, while the train was travelling at 41 mph in a 0.9° right-hand curve, a train-initiated emergency air brake application occurred at Mile 101.1 near Devlin (Figure 1). After the train came to a stop, the crew conducted an inspection and found that 13 hopper cars near the tail end (positions 119 to 131) had derailed (Figure 2). Most of the derailed cars were extensively damaged and released their product. There were no injuries.

Figure 2. View of tail-end locomotive and derailed cars (Source: Canadian National Railway Company)

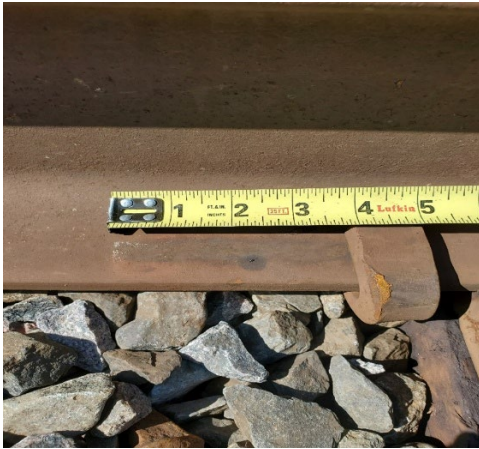
In July 2025, the TSB examined the track in the area of the derailment. Signs of previous rail creep<sup>2</sup> were observed in several locations. At Mile 101.8, the anchors had been repositioned by up to 4 inches (Figure 3) during repairs conducted after the derailment. The track in the adjacent siding showed signs of rail creep; in some cases, the anchors were displaced by up to 6 inches (Figure 4). All the anchor displacements on the main track were in the eastward direction, indicating that the rail creep was in the direction of the heavy tonnage traffic.

Figure 3. Rail anchor repositioned by 4 inches at Mile 101.8 on the Fort Frances Subdivision main line (Source: TSB)

The investigation determined that this practice was not consistently followed during post-derailment repairs at Mile 101.8, as some anchors were manually slid along the rail base by up to 4 inches with a sledge hammer.

So as not to compromise the structural integrity of tracks, it is important that track maintenance employees adhere to the appropriate operational procedures for the work they are carrying out, such as when adjusting rail anchors.

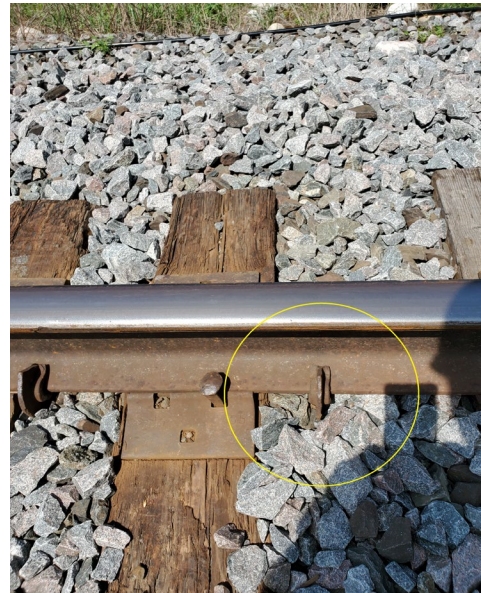
Figure 4. Track in the siding adjacent to the point of derailment, showing an anchor displaced several inches away from the tie (Source: TSB)

Rail creep is a sign of compressive stress in the rail. Excessive compressive forces can cause track buckling (lateral deformation of the track). Compressive stress can be proactively managed by

reinforcing track securement (for instance by adjusting the position of the anchors closer to the ties or by replacing the anchors) or by destressing the rails.<sup>3</sup>
