The Washington Metrorail Safety Commission

Safety Audit

Audit of
Roadway
Maintenance
Machines Program

Final Report:
October 18, 2023

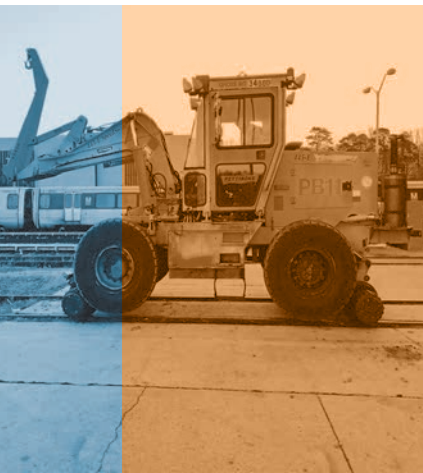
This audit identified positive practices such as Metrorail's identification of and steps to address brake beam failures, improvements to contractor vehicle inspections, and progress toward data logging for RMMs.

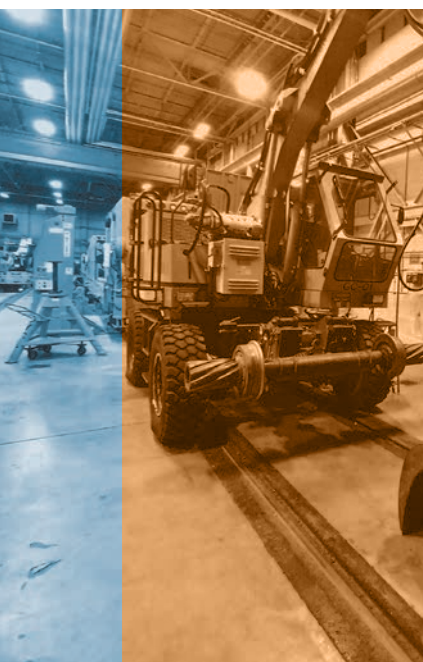
Metrorail does not ensure the use of adequate fall protection when working on or around RMMs.

Metrorail must complete development of and implement a comprehensive fall protection program. This must include Metrorail conducting safety promotion activities to ensure that personnel working on and around RMMs (from departments including CTEM, TRST, PLNT) understand the hazard of falls from height and the necessary mitigations to keep themselves and their colleagues safe.

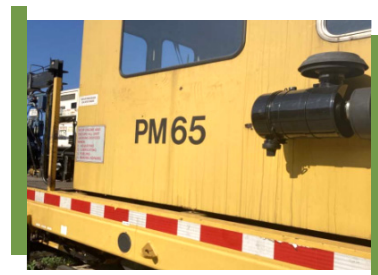
On July 9, 2021, a runaway maintenance vehicle collided with equipment in an area where personnel were working. Prime Mover (PM) 65, rolled, not under the control of an operator, approximately 250 feet down a graded section of track near Southern Ave Station into a location where Metrorail personnel were actively working. The Equipment Operator and the Roadway Worker In-Charge (RWIC) on PM 65 yelled at the workers to get out of the way, and the workers ran out of the way just before the vehicle

Movement in dark territory without coordination creates a risk that a vehicle could strike a roadway worker or another vehicle.

reached their location. PM 65 collided with a Geismar Track Torquing Machine that was being used as part of overnight work on switch point and stock rail replacement to properly adjust and secure the running rail. The machine is regularly used to torque rail fasteners. Given its weight, the machine is typically placed on the rails from a flatcar using a crane. Due to the work, third rail power was de-energized in the area at the time of the collision. The work crew did not immediately report this event as required by Metrorail rules and procedures.

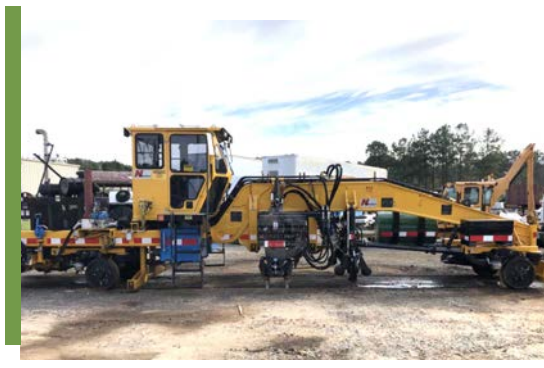
On October 1, 2021, an equipment operator operated a Tie Remover and Inserter (TRIPP) Machine above the permitted speed, the vehicle derailed, and the Equipment Operator did not immediately report the derailment to the Rail Operations Control Center (ROCC). The investigation suggested the Equipment Operator was operating the vehicle in 'work mode' rather than 'travel mode', increasing the risk that this type of derailment would occur

due to the way the vehicle interacts with the rails in each mode. In work mode, the vehicle is not supposed to be operated at more than 5 mph. TR05 was travelling at approximately 20 mph, 5 mph greater than the maximum permitted speed in a convoy block of 15 mph, when the front end of the unit derailed after departing Deanwood Station. Metrorail rules require the TRIPP Machine be operated at no greater than 15 mph in any circumstance. Other investigations, such as W-0135 of a red signal overrun near Cheverly Station on July 30, 2021 also demonstrated equipment operators exceeding the allowed speed in a convoy block.

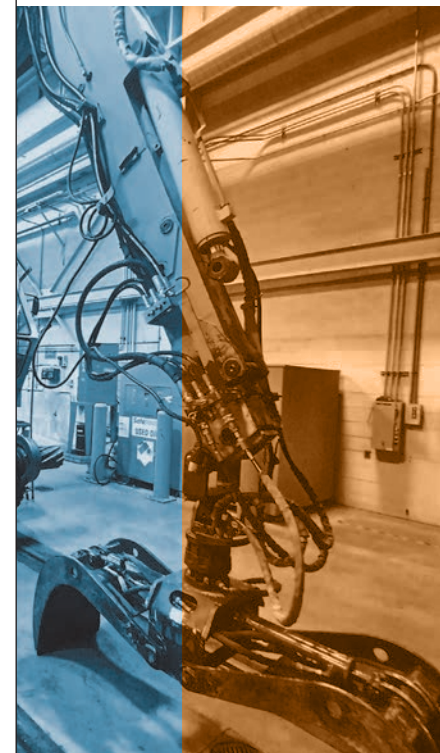
Metrorail's procedural deficiencies allowed equipment that did not meet its safety or operational requirements to be purchased and accepted.

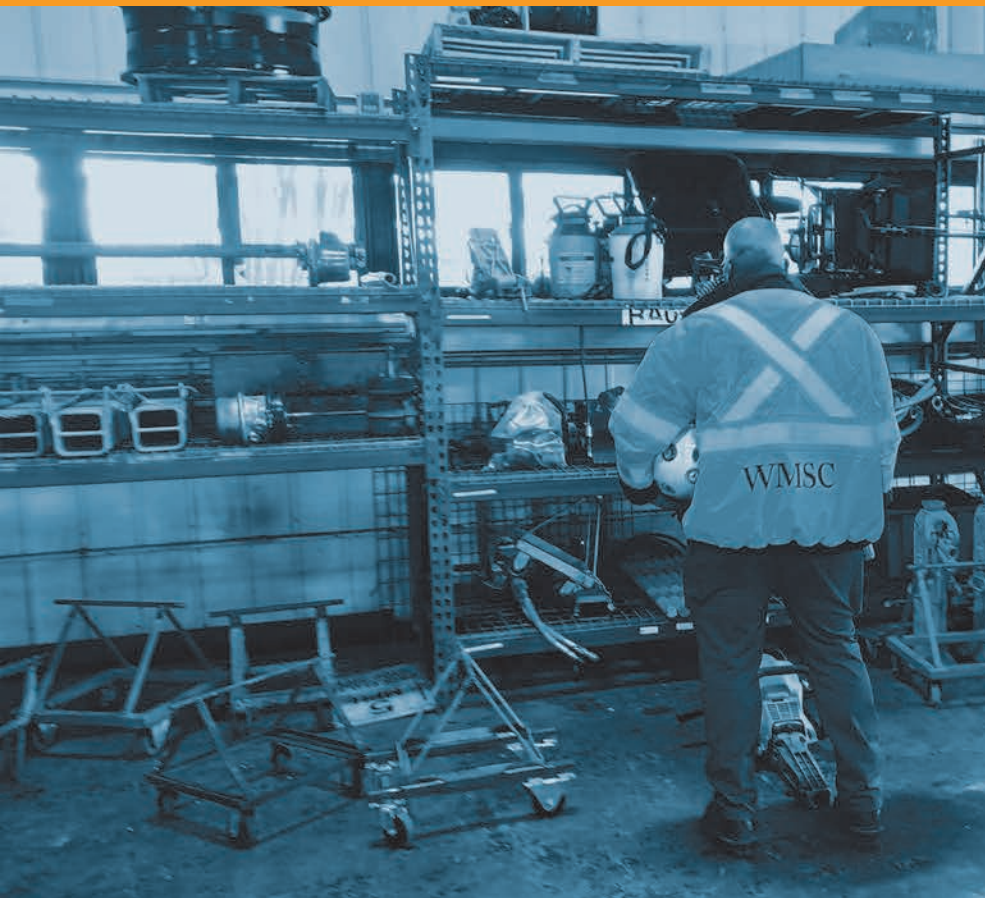
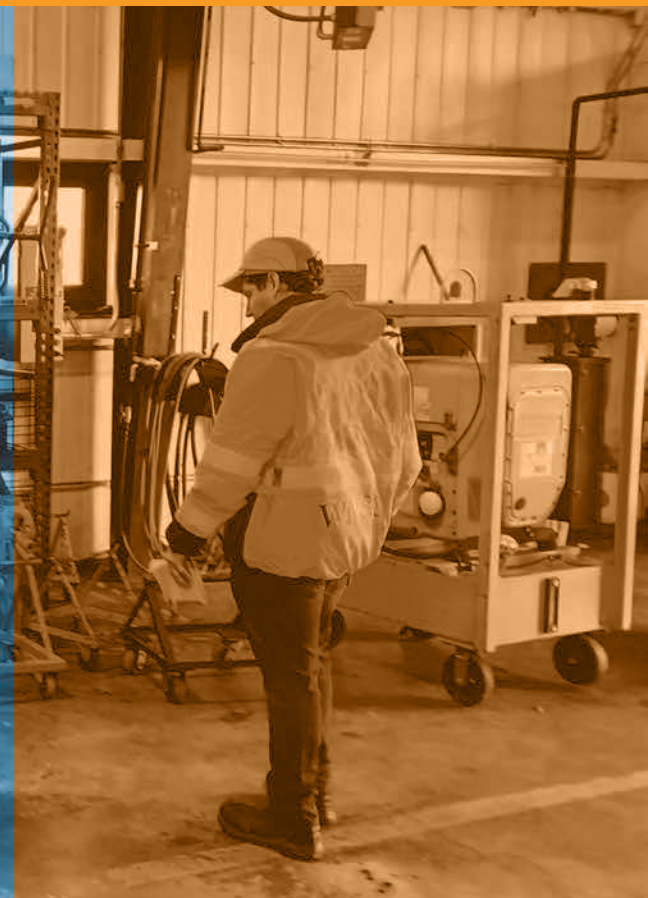
- Metrorail identified in December 2021, and has since been taking steps to address, a safety issue related to brake beams on Plasser RMMs, primarily Prime Movers. Specifically, Metrorail identified a set of failures across approximately 12 units with similar brake beam designs related to a brake torque beam fulcrum block weld joint. Metrorail has been transparent about identifying and providing information about its progress on this issue, and responsible groups have kept various internal Metrorail departments (and the WMSC) up to date over the course of this process. Recent work includes developing a fix for this safety issue through engineering tests and associated communications, ensuring that parts that were delivered that did not meet safety and quality requirements were rejected, continuing to ensure that the RMMs remain out of service until they are safe to operate, and regularly turning on engines on the vehicles that have remained out of service long-term (more than one year at the time of this audit).

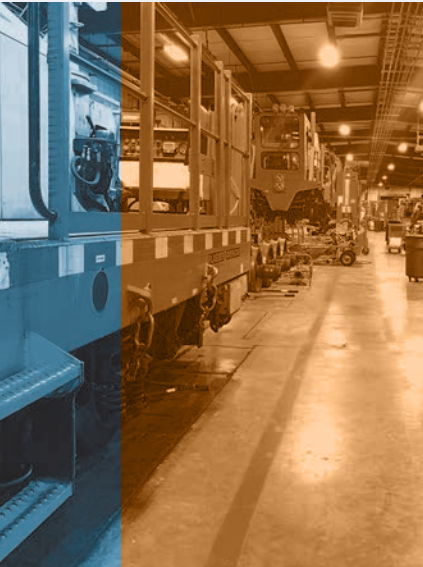
Metrorail is not accurately counting the number of personnel certified on each vehicle, with some recertified personnel being double counted.

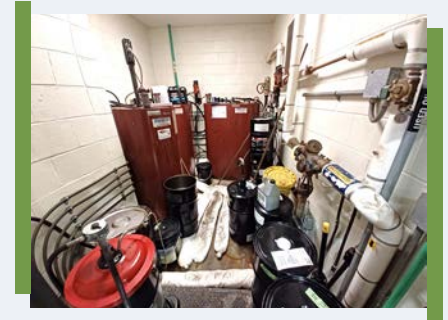
WMSC personnel at the Greenbelt CTEM shop observed a water and oil mixture on the floor of Room F-105 (labelled Lube Room). It appeared that this water and oil mixture was the result of an ongoing leak. This room has a drain, and a posted sign indicated that the room drains to an oil skimmer. This room contains engine oil (275-gallon capacity tank), hydraulic oil (275-gallon capacity tank), transmission fluid (275-gallon capacity tank), grease, and a water leak from the non-potable water line. There were supplies in the room that appeared to be temporary mitigations due to the leaks. There were also materials in the room that were not on spill pallets. The WMSC also observed deficiencies in safety signage, including NFPA signage. When the WMSC brought these hazards to the attention of Metrorail, Metrorail corrected these safety issues over the following weeks by placing drums on spill pallets, cleaning the room, replacing a broken door handle, creating a work order to replace a leaking seal on the backflow preventer, and adding the necessary NFPA diamond signage to indicate to first responders the hazardous materials in the room.

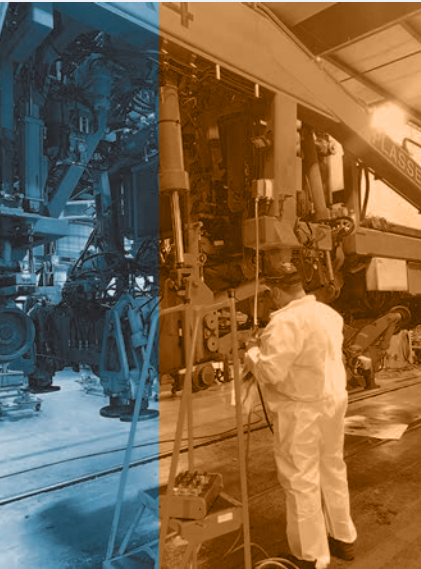
In response to further follow-up questions, Metrorail's Office of Occupational Safety and Health (OSH) acknowledged that the work observed by the WMSC did not comply with OSHA regulations or with WMATA's fall protection standards.

Metrorail has also had fall protection issues outside of this audit. For example, the WMSC observed, and Metrorail then corrected, missing fall protection barriers in the Alexandria Rail Yard storeroom in February 2023, and Metrorail has experienced serious injuries, such as due to improper or a lack of fall protection such as a serious injury at the Queenstown Road Repair and Maintenance Supply Storage Facility on April 25, 2022 (W-0176).

Metrorail's Office of Occupational Safety and Health (OSH) acknowledged that the work observed by the WMSC did not comply with OSHA regulations or with WMATA's fall protection standards.

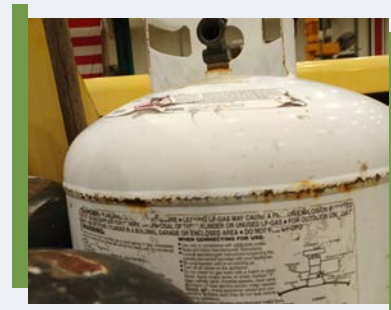
In another example of Metrorail not identifying and managing hazards, during site visits for this audit, The WMSC observed a propane tank on a Prime Mover inside the Greenbelt CTEM shop that was labeled “FOR OUTDOOR USE ONLY” and “DO NOT USE OR STORE CYLINDER IN A BUILDING, GARAGE OR ENCLOSED AREA.” The WMSC raised this to Metrorail as a potential safety concern, and Metrorail responded, “The label on white propane cylinders identifying “FOR OUTDOOR USE ONLY” and “DO NOT USE OR STORE CYLINDER IN A BUILDING, GARAGE OR ENCLOSED AREA” is a non-code-compliant label installed by the gas manufacturer.

The equipment manufacturer that Metrorail procured the cylinder from affixed the warning label. Metrorail did not provide a basis for ignoring the safety information, and Metrorail had not previously identified this issue until the WMSC's site visit.

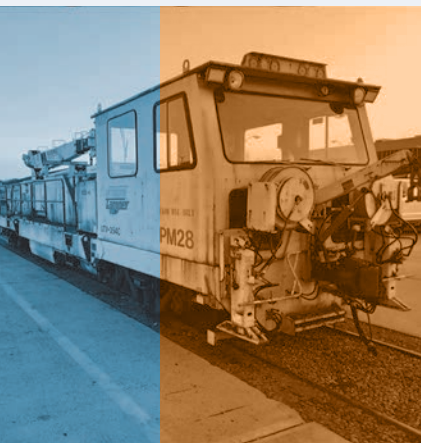
Metrorail requires annual hi-rail gear safety inspections. Each of these vehicles were more than 1.5 years past due for these safety inspections.

Metrorail stated that a contract was out for solicitation in March 2023 that would cover those vehicles.

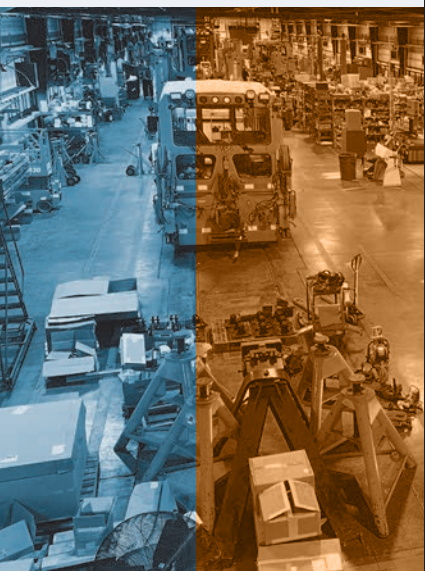
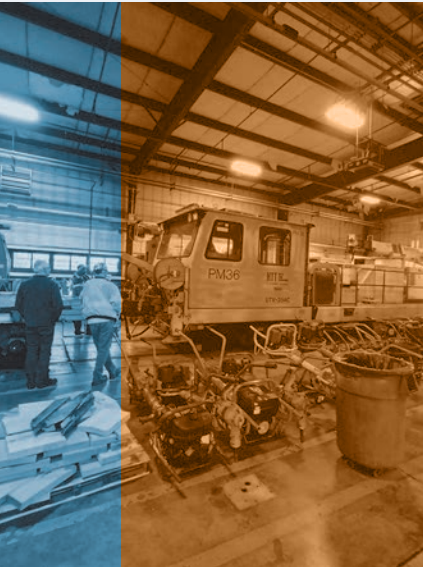
Other systems such as plows that may be attached to units similarly sit without maintenance or checks for extended periods, which allows for corrosion.

Metrorail stated that it would rely on its regular preventive maintenance of each vehicle, however this is designed around the use of the vehicles for specified hours or miles, not around vehicles that are not used and might risk corrosion, drying out of seals or other features, or other issues from an extended lack of use that could prevent the vehicles from being available if needed for maintenance or repair work.

Metrorail may develop cold storage procedures and other processes to document its process to start and check equipment on a regular basis that is not being regularly used, including defining the minimum nature and frequency of such activities.

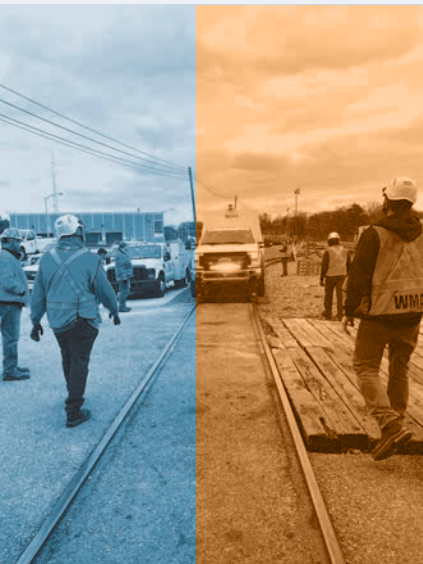
Metrorail provided operational manuals and training that do not provide personnel with clear, consistently presented, understandable information.

Metrorail may develop and implement a consistent, complete format for training and manuals in alignment with its Quality Management System that documents operational restrictions and allows personnel to identify where to look for such information, and may incorporate these improvements into a recurring troubleshooting training (Note: Part of this corrective action may incorporate elements of iCAPA CTEM-22-03).
