Railroad Investigation Report: RIR-24-04

# 1 Port Authority Transit Corporation Train 2 Strikes Two Subcontractor Employees

Camden, New Jersey  
October 14, 2022

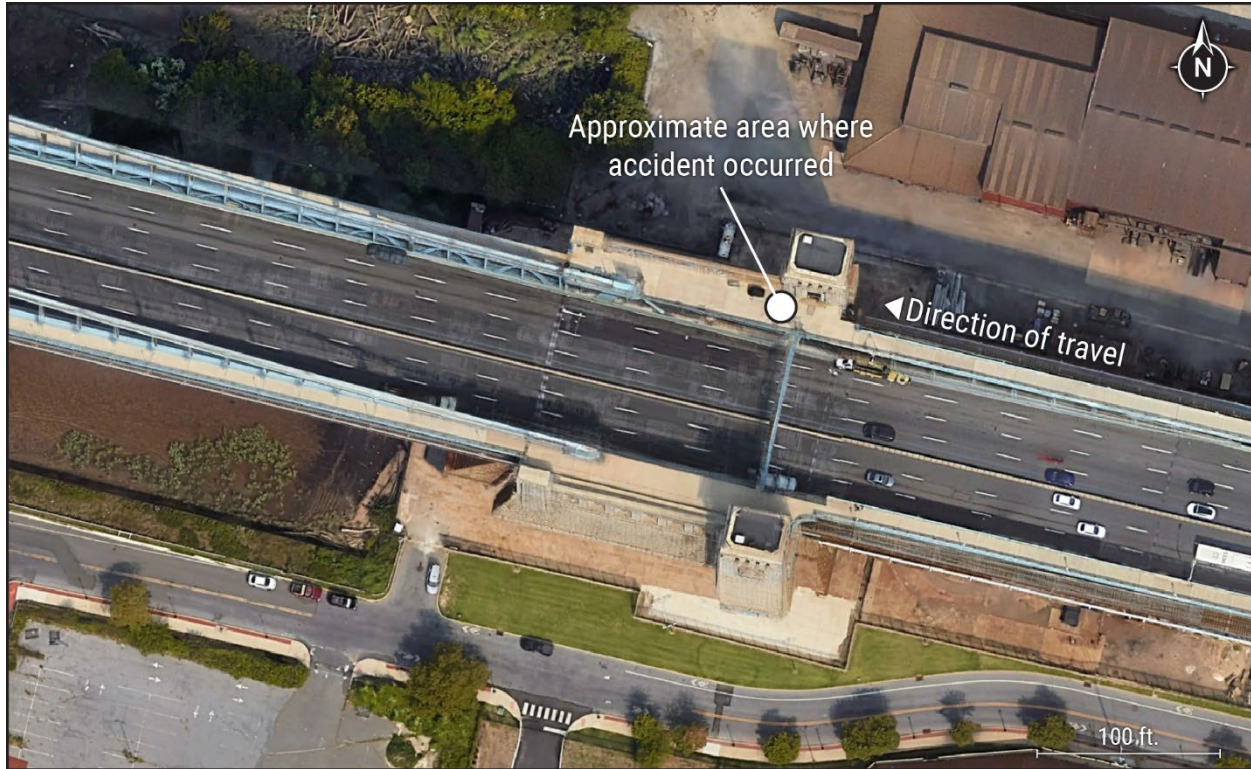
On October 14, 2022, about 9:21 p.m. local time, Port Authority Transit Corporation (PATCO) train Westbound #1 struck and killed two subcontractor employees from JPC Group, Inc. on Main Track 2 on the Benjamin Franklin Bridge in Camden, New Jersey.<sup>1</sup> The train was traveling west at 33 mph and had a train operator (operator) and 68 passengers aboard; 8 passengers were in the lead car. At the time of the accident, conditions were dark and clear, and the temperature was 59°F.<sup>2</sup> Figure 1 shows the location of the accident.

**Figure 1.** Overhead view of the Benjamin Franklin Bridge.
